Case Study

Corrosion damage on wind turbines? No longer a problem.

New RENOLIT CP corrosion protection film performs outstandingly in long-term test.

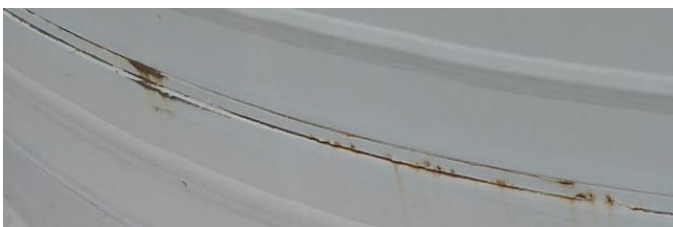
Visible signs of corrosion around a flange

The flange at the base of the tower was prepared for the application of **RENOLIT CP** corrosion protection film. All existing corrosion and the remaining paint were removed with a rotating wire brush and then intensively cleaned. Finally, a zinc primer was applied. As a comparison: To achieve the same level of corrosion protection offered by **RENOLIT CP** with paint, after the primer has dried, two coating layers of paint plus drying time for each would be necessary.

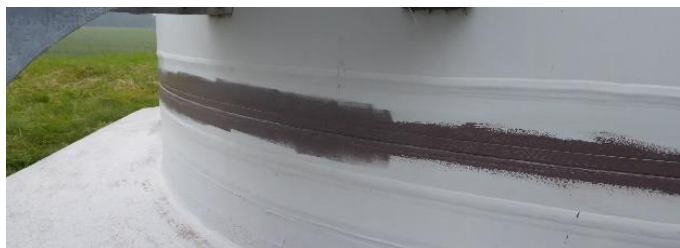
Primer applied to both welded seams

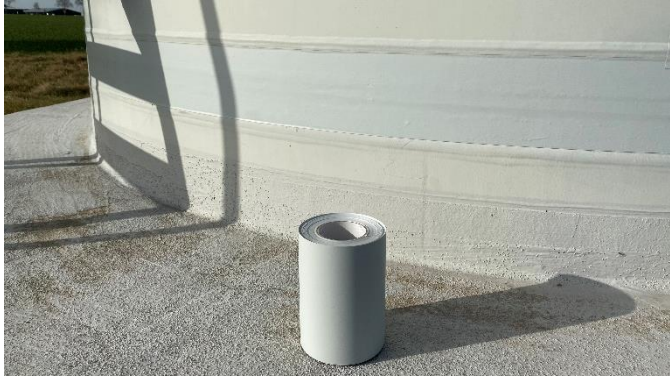
The film can be used in roll form as shown here or also in the form of patches.

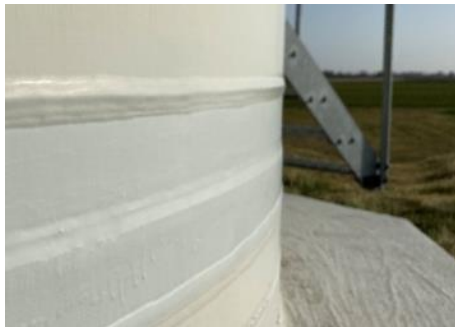
Even after 20 months, the film is still adhering well around the flanges and there is absolutely no adhesive peelings on any of the test areas.

The test result was very satisfactory: At the end of the test phase in February 2021, there is no adhesive peelings or traces of drainage due to chalking in the flange areas or around the hatch. The film provided complete corrosion protection on all treated surfaces.

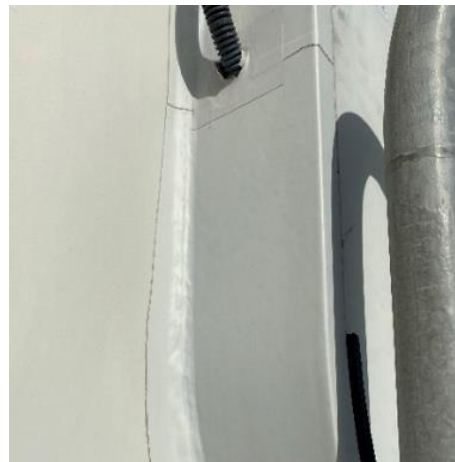
On difficult geometries such as the hatch, **RENOLIT CP** can be applied and fit well. When correctly handled, the surfaces protected by film show absolutely no signs of corrosion during the test.

Finally, the base was applied with a test strip (12m long and 0.19m wide). In addition, as a trial, the tower hatch was also applied with **RENOLIT CP**. This is also an area which is highly prone to corrosion with its edges, 90° angles and seams.

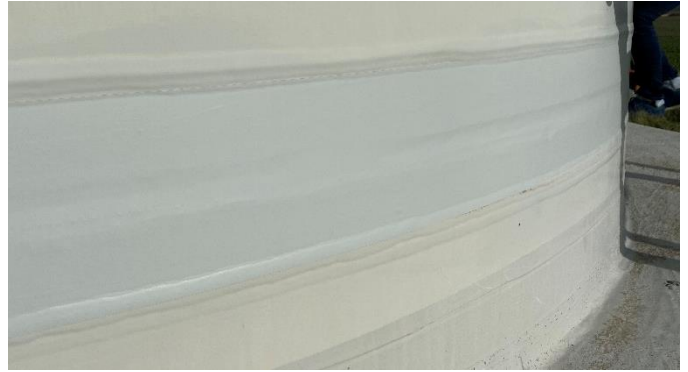
This shows the standard RAL colour “light grey” of the **RENOLIT CP** compared to the faded original paint finish which was originally the same colour.

The colour of **RENOLIT CP** is RAL 7035, “light grey” – the colour in which about 90% of all wind turbines are originally manufactured.
