**Test report no.:** 127028/17

**Order:** Determination of resistance to root damage to flexible sheets and coatings for roof planting according to FLL (2008) on the flexible sheet "Alkorplan L 35177" nominal thickness 1.5 mm

## 1 Order

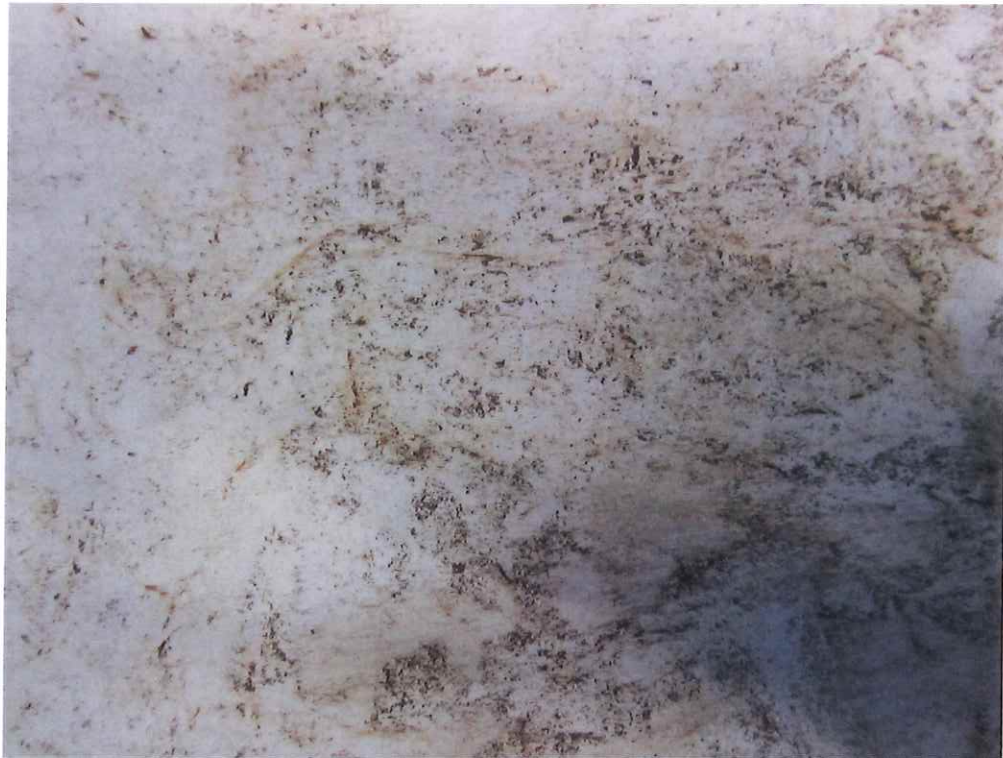
Figure 1: Membrane surface

At the end of the test period (December 2019) the containers were emptied for a detailed check of the membrane "Alkorplan L 35177" for root or rhizome penetration and perforation. The surface and the joints of the tested membrane did not show any perforations or penetrations caused by roots and rhizomes, see figure 1 – 3.
